Impinging Step Trains on a SiC Growth Surface

First Place, 2000 Ceramographic competition
Classification: Optical Microscopy

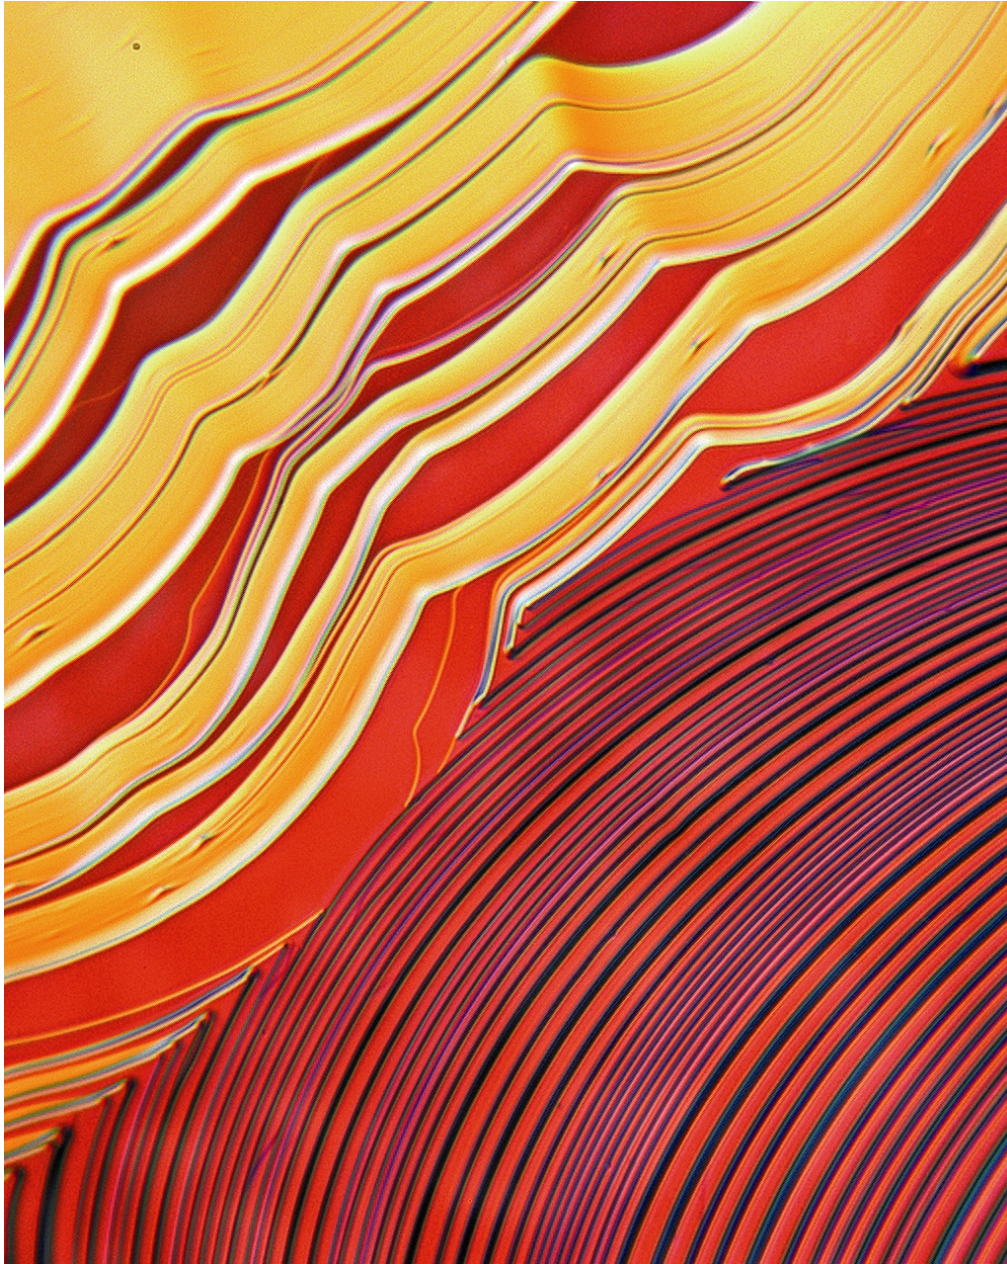
An interference contrast micrograph of a SiC growth surface. The 6H SiC crystal was grown by the seeded sublimation method at 2300 °C. The micrograph illustrates the point at which trains of growth steps from nearby sources (super screw dislocations) impinge. The steps originating from the lower right are almost ideal concentric circles. The steps progressing from the upper left exhibit instabilities, possibly caused by pinning points or competitive sources.
